**BUREAU OF SHIPS  
CONFERENCE**

**HY-80 STEEL FABRICATION IN  
SUBMARINE CONSTRUCTION**

**AT BUREAU OF SHIPS  
21-22 MARCH 1960**

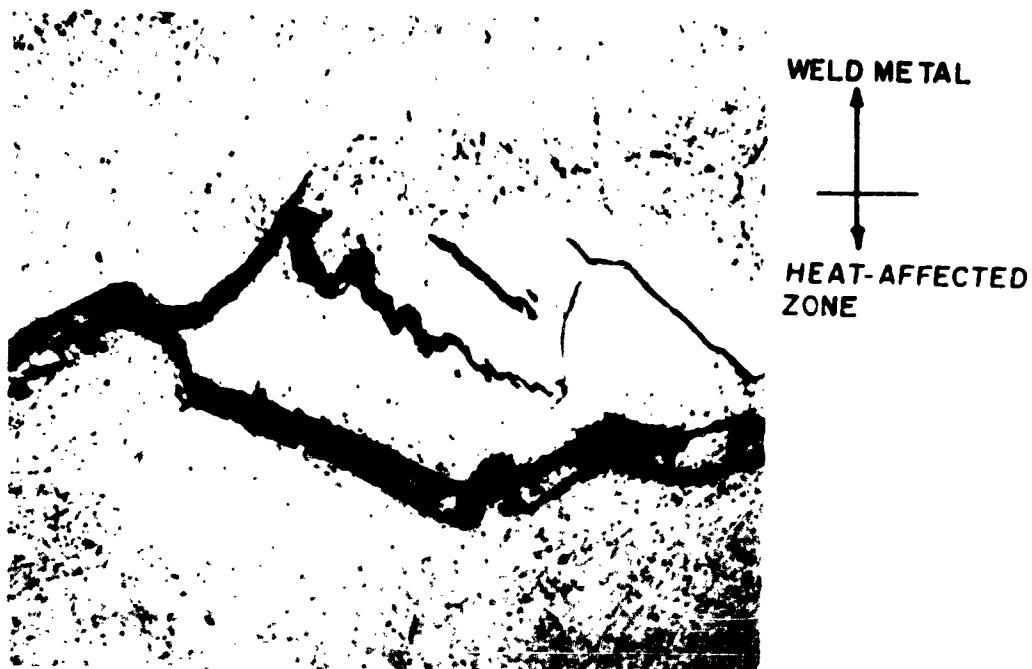
Figure 21. Typical heat-affected-zone root crack in single-pass-welded cruciform-shaped specimen of heavy-gage-composition HY-80 steel. As-welded condition. Etched in Super Picral. X500.

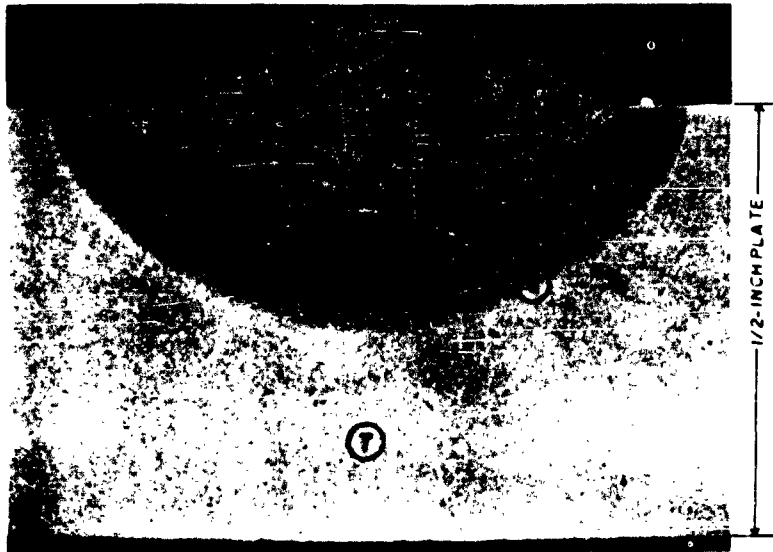
Figure 22. Photomicrograph of bead weld in USS "T-1" steel plate welded at 70 F. Numbered circles identify the zones described below. Etched in Nital. X7.

Location	Description
1	Weld Metal
2	Weld Metal and Maximum-Grain-Coarsened Heat-Affected Zone
3	Moderately Grain-Coarsened Heat-Affected Zone
4	Grain-Refined Heat-Affected Zone
5	Grain-Refined Heat-Affected Zone
6	A <sub>1</sub> -A <sub>3</sub> Heat-Affected Zone
7	Base Metal

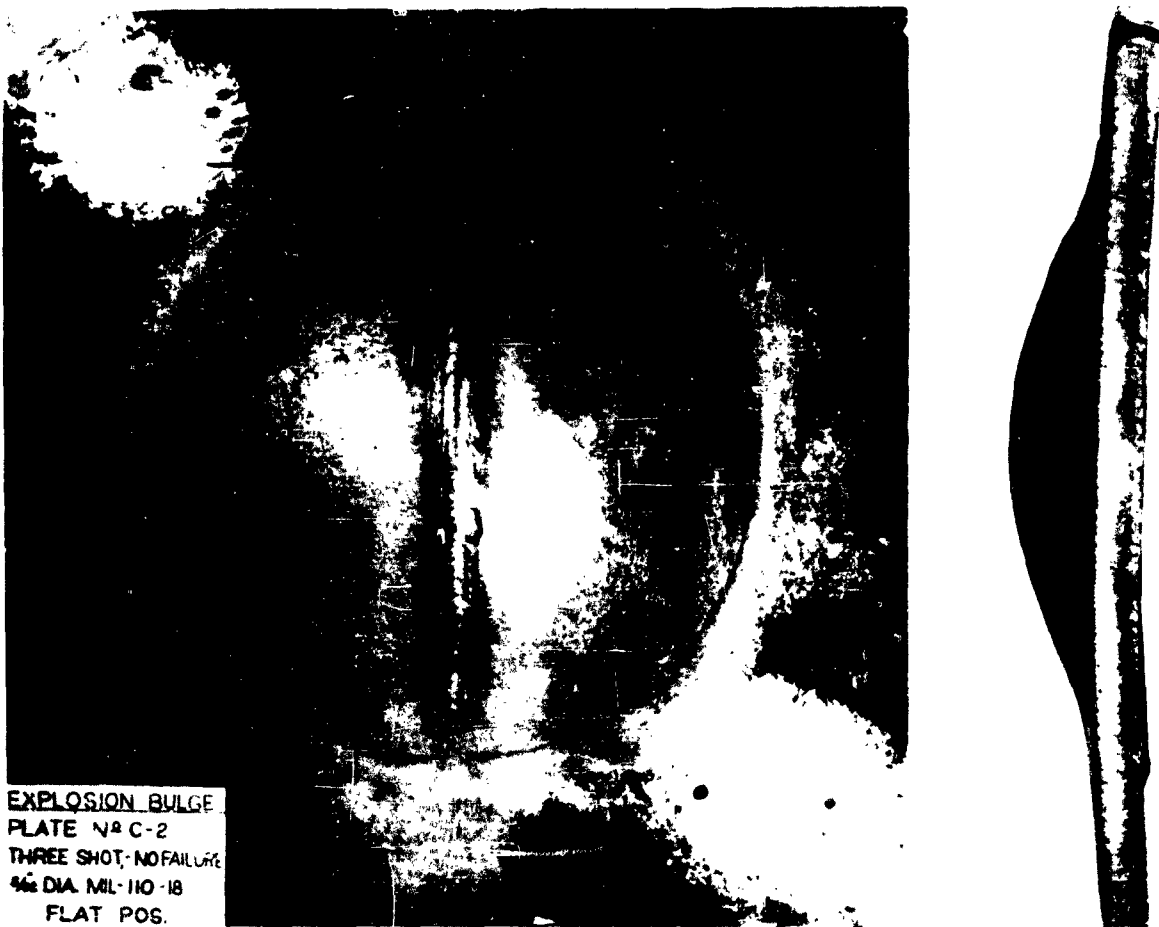
Figure 11 — Explosion Bulge Plate No. C-2 Three Shot, - No Failure 5/32" Dia. MIL-110-18 Flat Pos.
